Faith and John Gaw Meem Preservation Trades Internship

My internship with HSFF consisted of 6 weeks primarily on-site at El Zagan building located on Canyon Road in Santa Fe. My first week included an orientation to the city's historic neighborhoods and an overview of how the Foundation's work fits into a bigger context of preservation advocacy and community engagement in the region. My main project was to re-plaster the north wall of the main El Zagan structure that currently house's the Foundation's headquarters and gallery space. The building has two foot thick adobe walls and dates from the mid 1800s, and has seen many layers of maintenance and modifications since then.

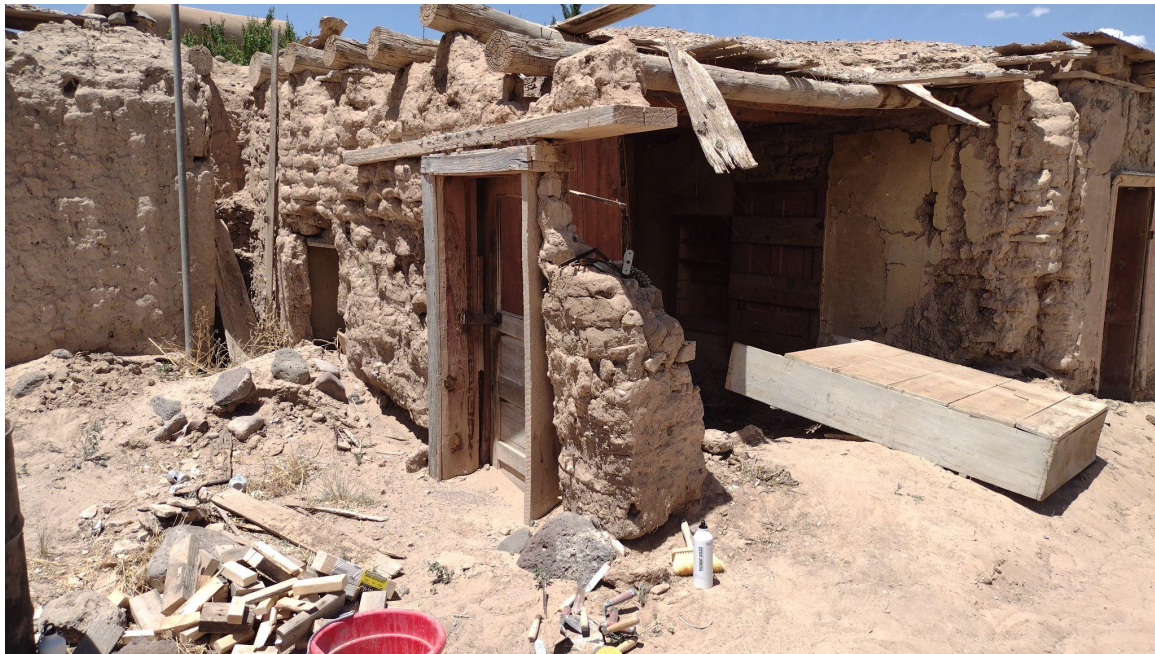
An example of a deteriorating home in Abiquiu, NM

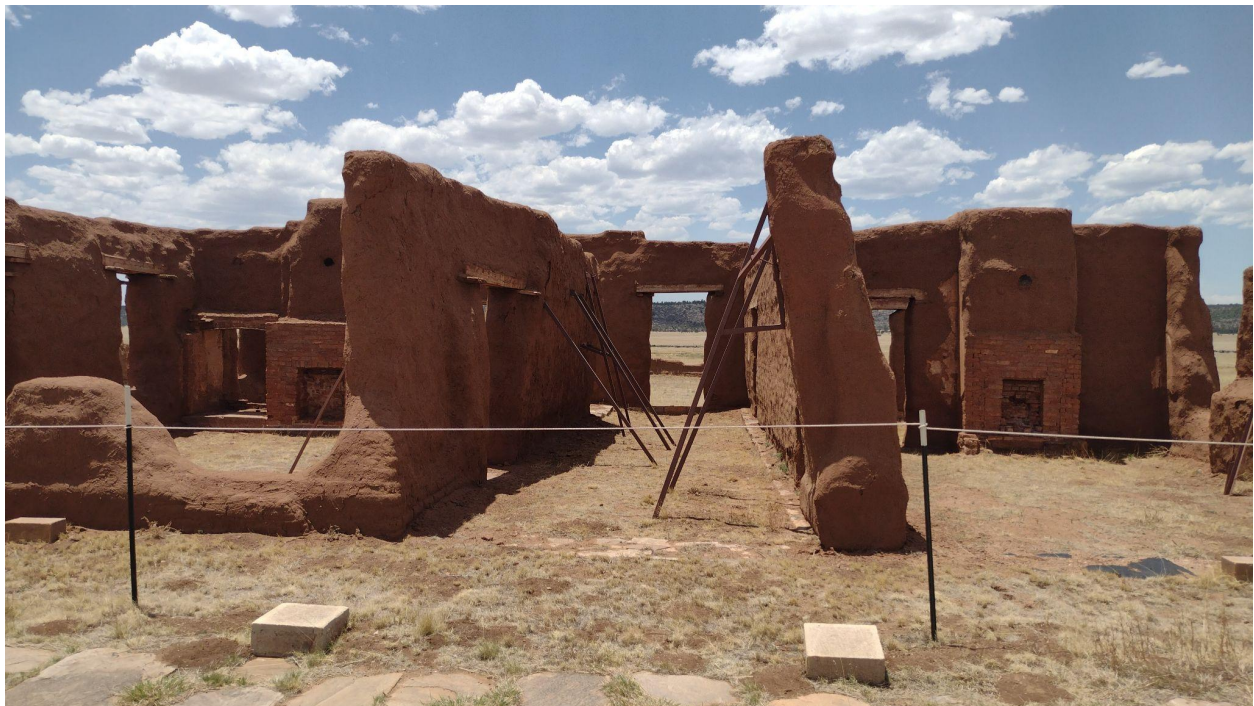
At Fort Union, we saw up-close how the walls are deteriorating, and measures put in place to slow this down. Adobe walls, whether in traditional pueblo buildings or in more recent settler buildings, depend on roof beams to maintain structural integrity. However, re-building roofs on these wall ruins is not currently feasible under NPS preservation standards. Policies may need to change to allow roofs. The tour guides highlighted the ways that walls are surveyed, including the important switch in paradigm from identifying structures by the rooms they once housed, and shifting towards an resource inventory that identifies specific walls, which are each deteriorating at different rates due to varying exposure to weather and elements.

Structural stabilization of adobe walls that might otherwise benefit from having a roof system

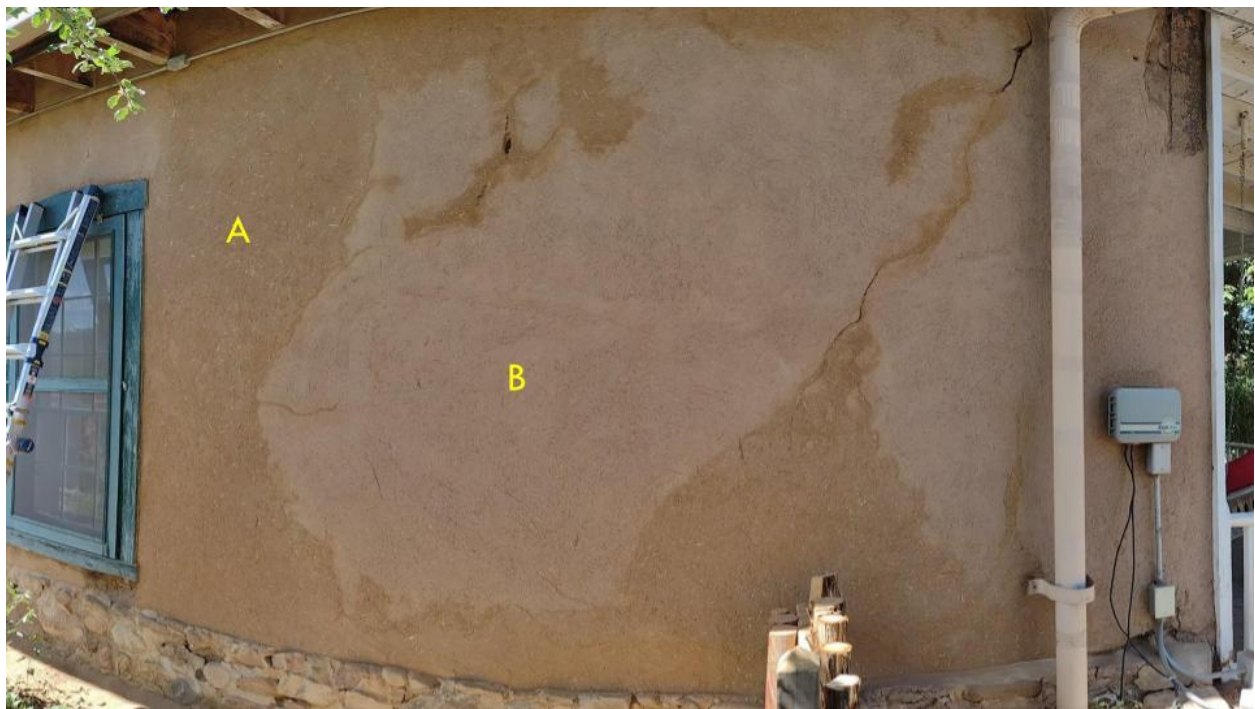
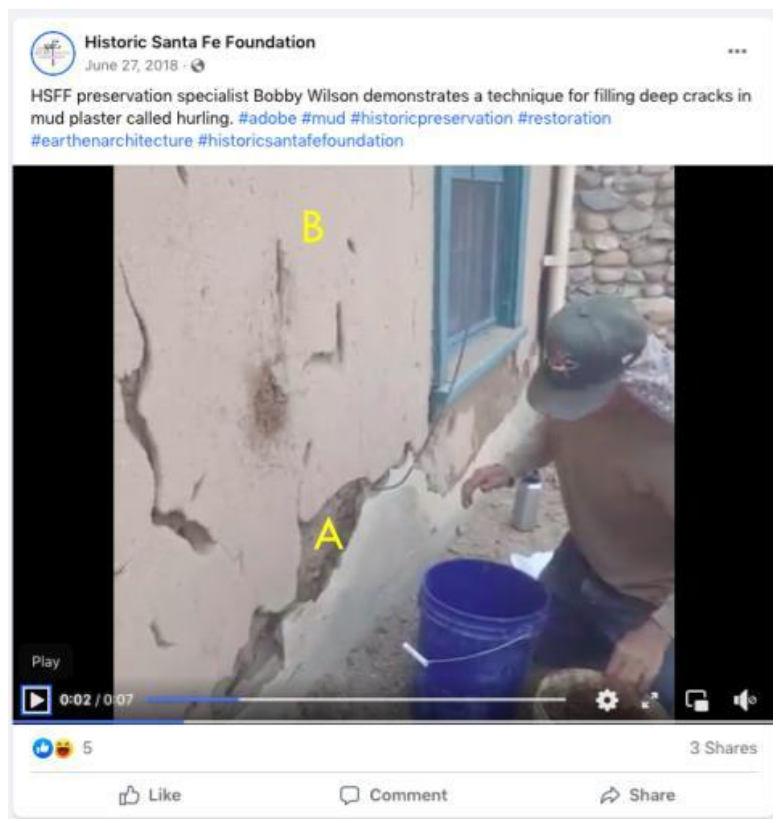
A: newer patchwork of repair plaster, B: older layer of pink-hued mud

Based on a HSFF Facebook video, the straw-rich layer is likely from repair work done to the pink-hue layer in 2018. It is unclear how old the pink-hue layer is.

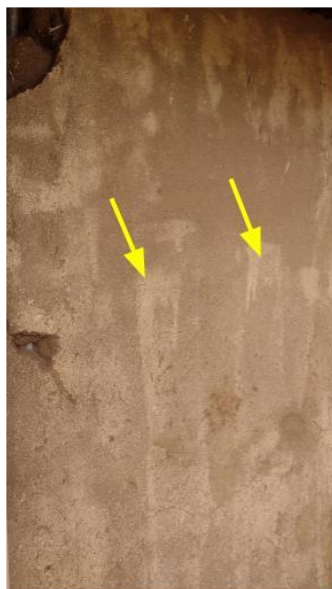
Upon dampening the visible plaster layers, I noticed that some areas seemed to repel the water and would not darken like adjacent layers. The vertical pattern seemed to match that of a paint roller, so it is possible that a transparent sealant was added at some point on top of the pink layer.

Arrows indicate possible location of a less permeable treatment on plaster

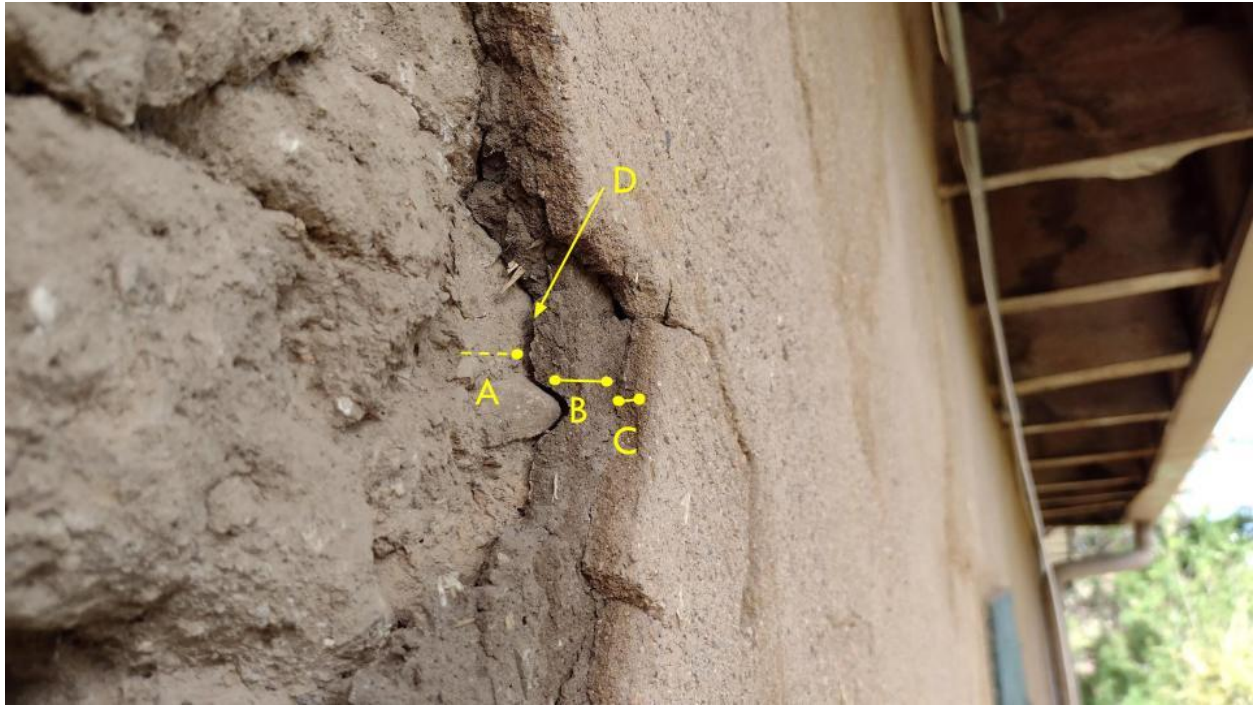
A: adobe brick wall, B: early (original?) layer of earthen plaster, C: Newest layer of earthen plaster, D: Gap typical of areas where early earthen plaster had separated from adobe wall

It is worth noting that the plaster would often detach from the wall at this location where the oldest plaster layer and the adobe wall meet. Tapping the loose plaster with a tool would often result in loose material falling out of this gap. This suggests that subsequent layers of mud plaster had good adhesion with each other, but the oldest layer becomes delaminated from the adobe wall with greater ease. This may be because of a silt-rich, clay-poor plaster mix with poor adhesion having been used as the first layer when the building was first coated. The layer closest to the adobe wall had a dull brown color and felt dusty and crumbly to the touch.

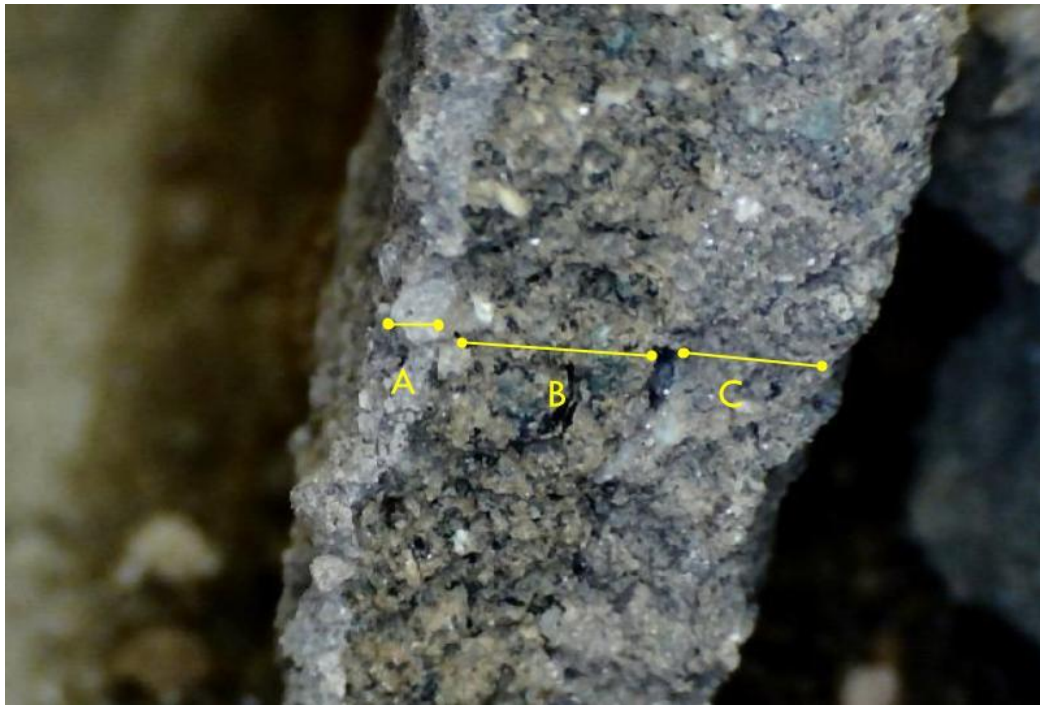
A: Likely a layer of the adobe brick that adhered to layer B, B: earliest layer of earthen plaster C: latest 'pink' layer of earthen plaster

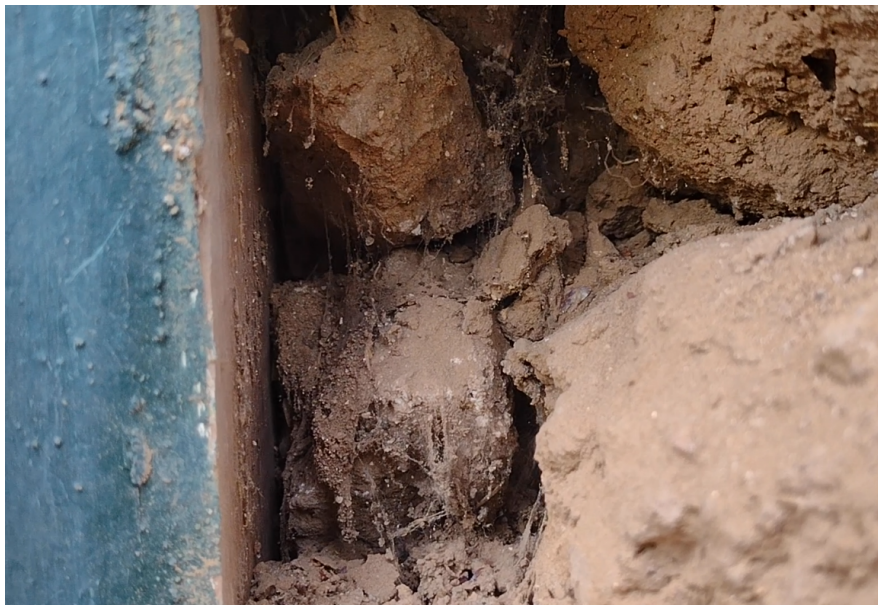
I located areas on the wall that already had cracks, or were notably hollow-sounding, and removed these loose areas of plaster first. Behind these loose areas were often empty spaces between adobe bricks, or places where the mortar had crumbled or become unsound. These areas often had cobwebs or other loose material stashed by small animals.

Example of area with loose/crumbled adobe bricks and presence of cobwebs

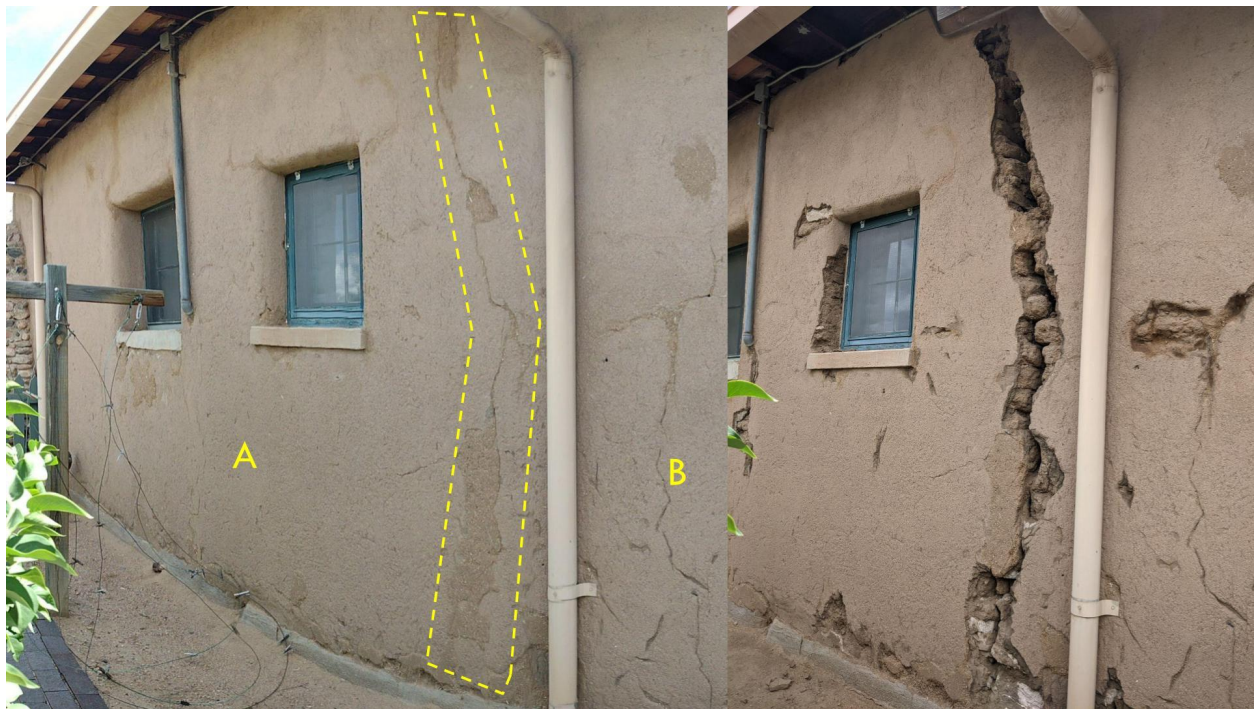
The longest continuous hollow area behind the wall, and also the deepest that I encountered, was at the location where the early adobe building and a subsequent addition came together. The crack ran from the base of the wall up to the roofline.

Before (left) and after (right) removing the plaster around the gap between the newer (A) and older (B) building

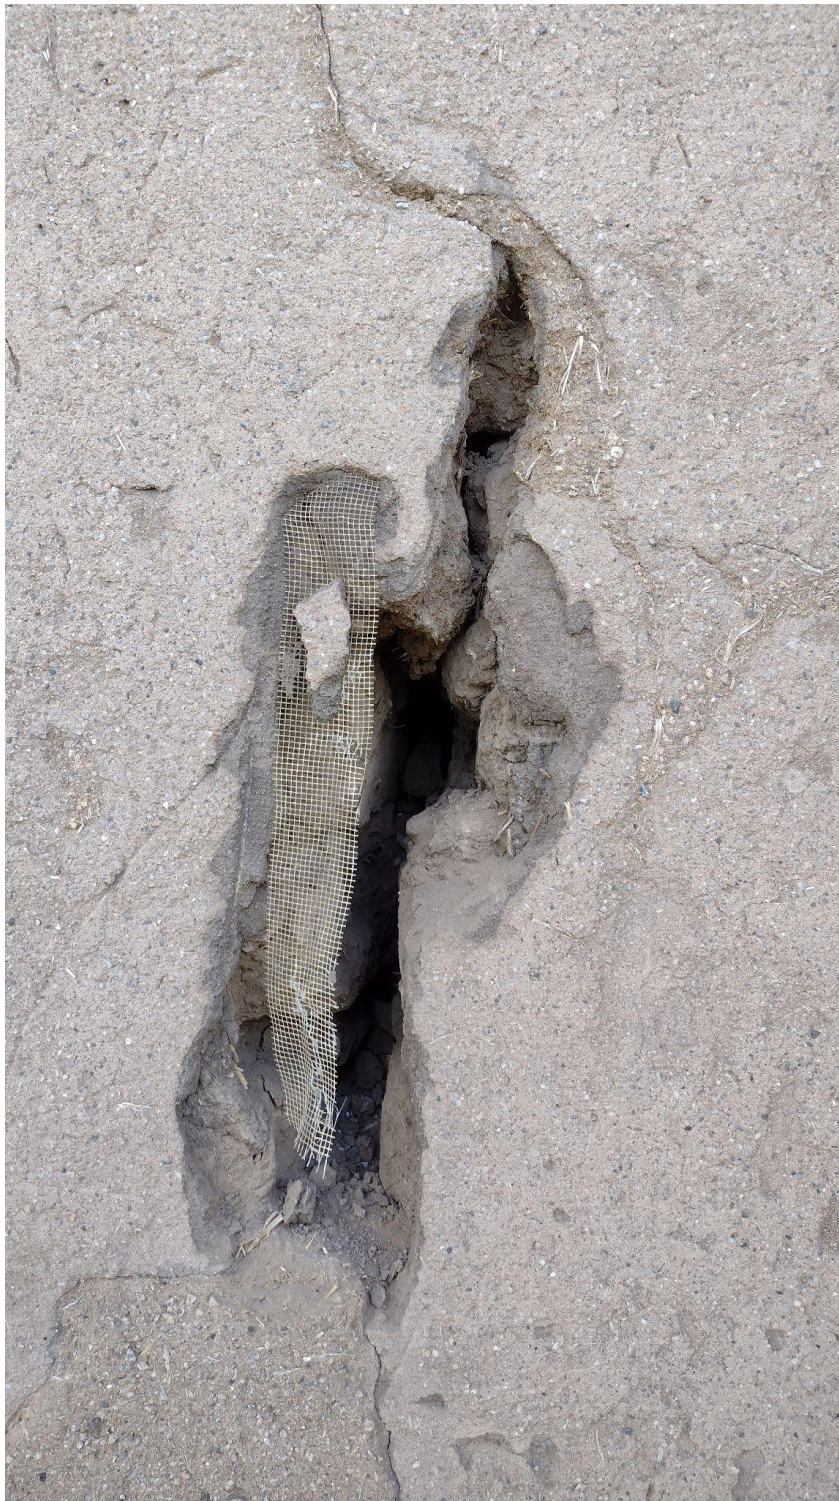
Use of drywall mesh tape used in previous repair efforts near large gap

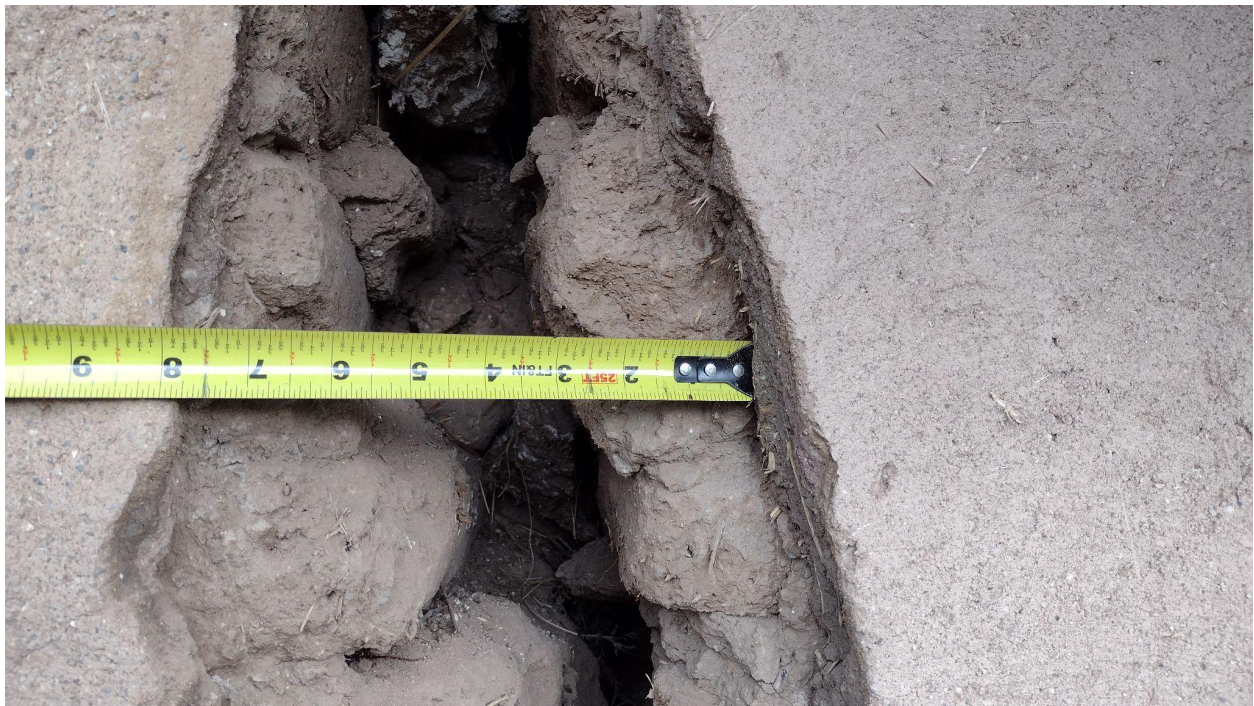
The bricks from the two different walls seem to have separated approximately 2 inches at the widest part of the gap. This is likely caused by the foundation and walls settling at different rates. However, given that there was no significant widening of crack on the most recent layer of plaster, it can be assumed that this settling and separation happened early on in the building's history. Subsequent removal of loose material I did in this area opened up the gap even more, and the adjoining exterior plaster to an even greater extent.

Separation of adobe bricks at union of new and old wall

If the building had shifted more recently, and after the most recent layer of plaster, a more obvious superficial crack would be visible. Ideally, when the addition was built, some bricks would have been removed from the old wall, and the new wall would have been 'stitched' into the old wall every few courses of bricks.

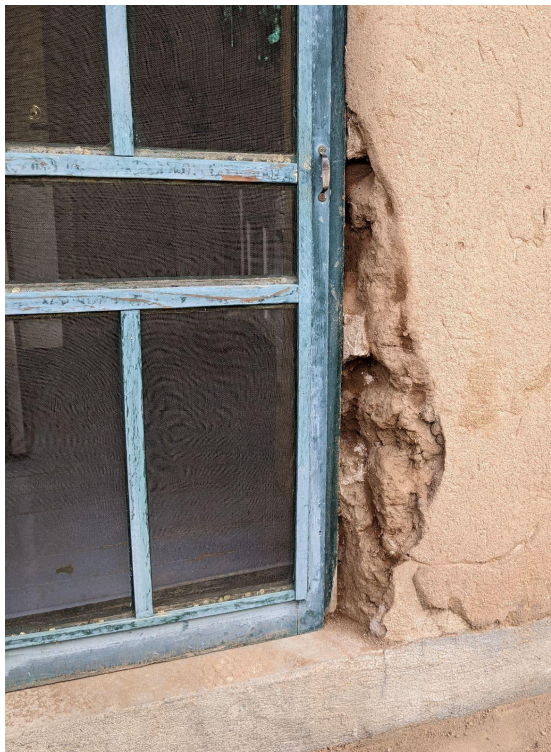
Loose material around door is removed (compare with next photo)

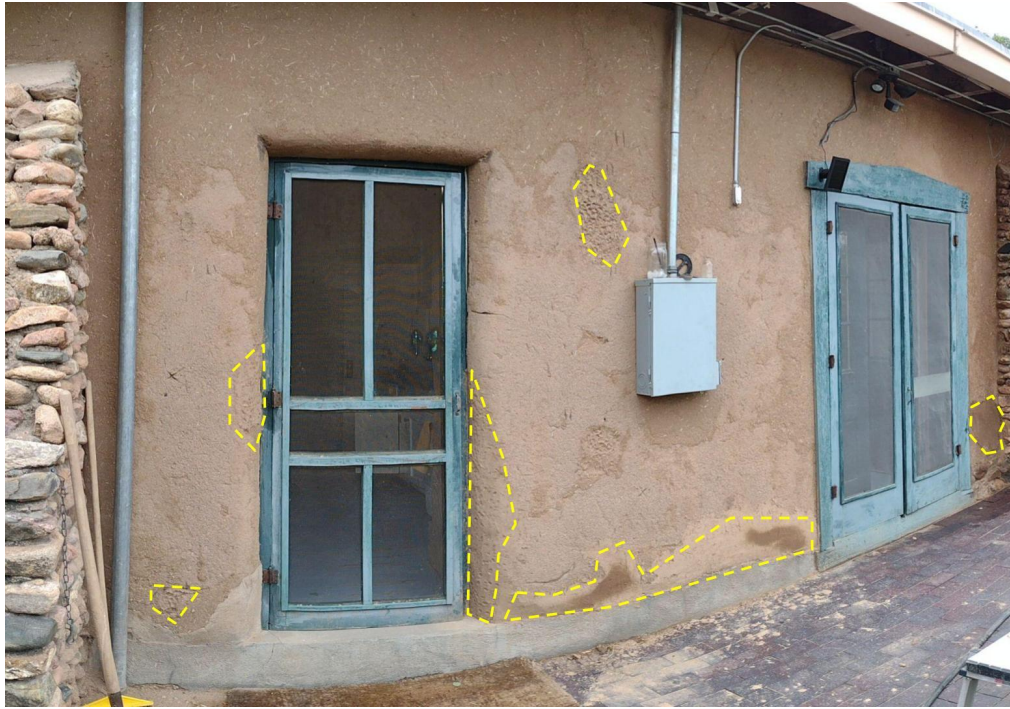
Yellow outlines highlight areas that had significant filling and repair, this wall is now ready for final exterior plaster

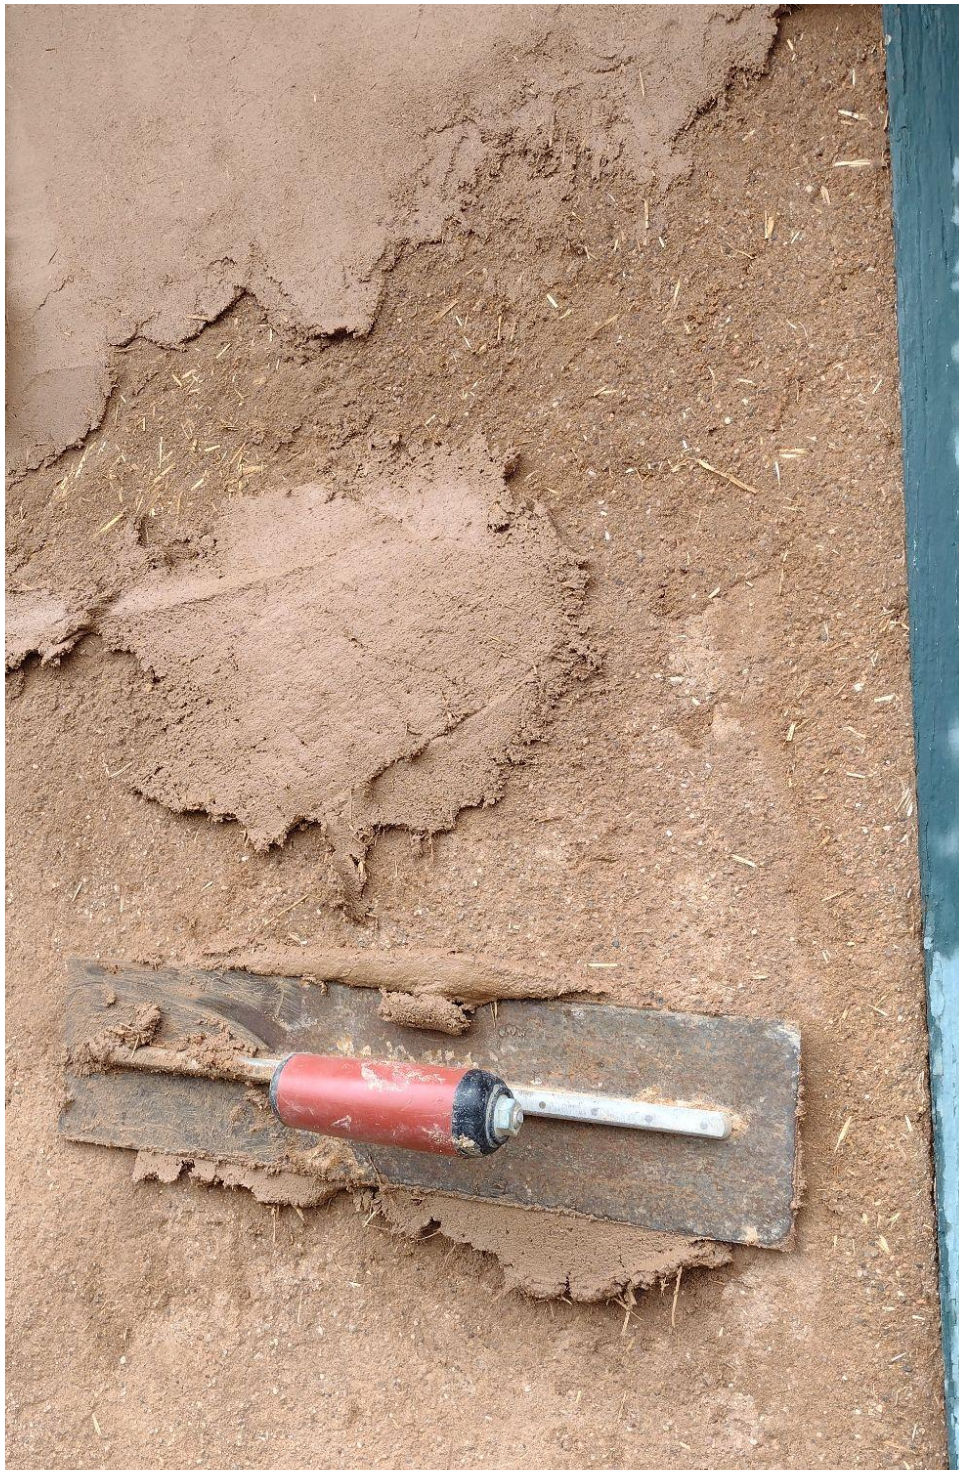
This plaster has become too dry and stiff to easily work with

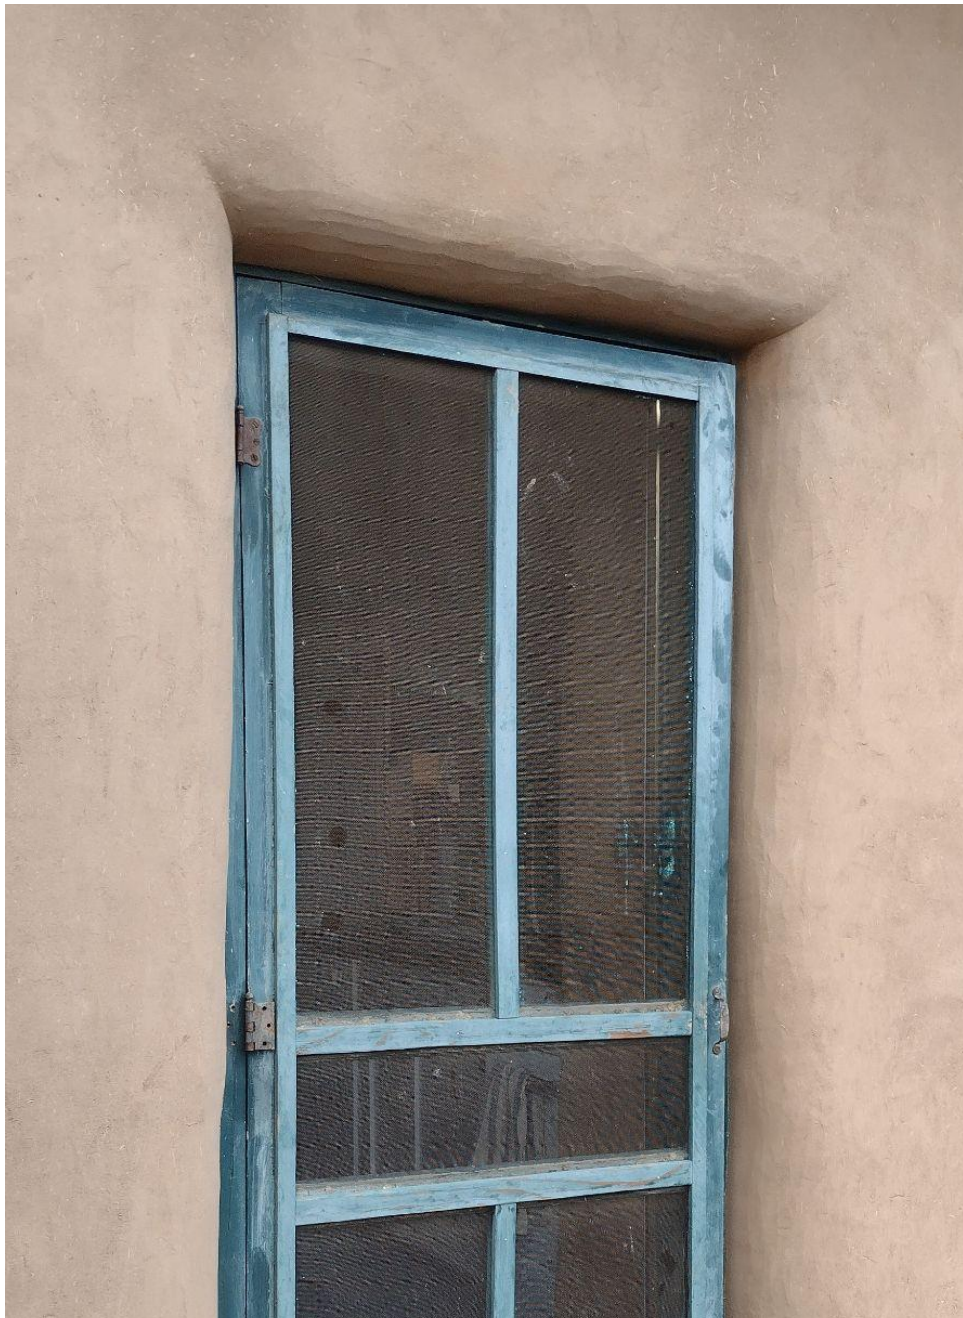
The doorways and window presented a challenging task of adhering the plaster to an overhung surface. I found that the typical plaster mix I was using would often peel off. I smeared a thin layer of very moist clay to the older plaster, this seemed to help the newer layer of plaster adhere to the overhangs. The curves of the door and window openings were difficult to apply plaster on a perfectly smooth fashion, so I opted to leave slighted fluted trowel strokes parallel to the length and width of the openings.

Final plaster layer applied to curved door opening

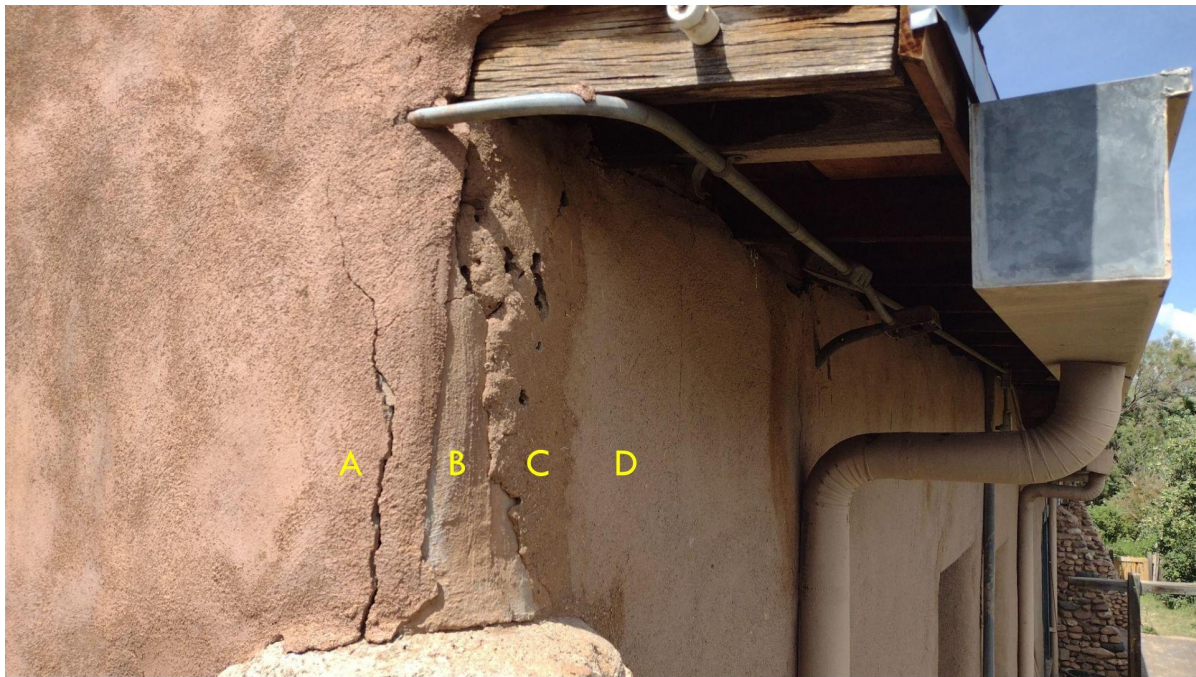
While working on the last part of the wall, I found some problems in the upper eastern corner that I had previously overlooked due to it being a difficult area to reach by ladder. This corner is where the timber rafters from the interior sit on the wall, alongside a lintel, some bricks, an electric conduit, a leaky downspout, and the stone buttress. Part of this area had been patched up with a cementitious plaster that had almost no adherence to the adobe wall. There were also areas that had been burrowed by an insect that had left large larvae behind, and plenty of loose cobweb. Removing the loose mud and mortar left a large area exposed. As with the other part of the wall, this was built up using a cob mixture, and finally, a couple layers of mud plaster.

A: Modern stucco plaster, B: cement element, C: recent earthen plaster (note insect entries),
D: 'pink' layer of plaster

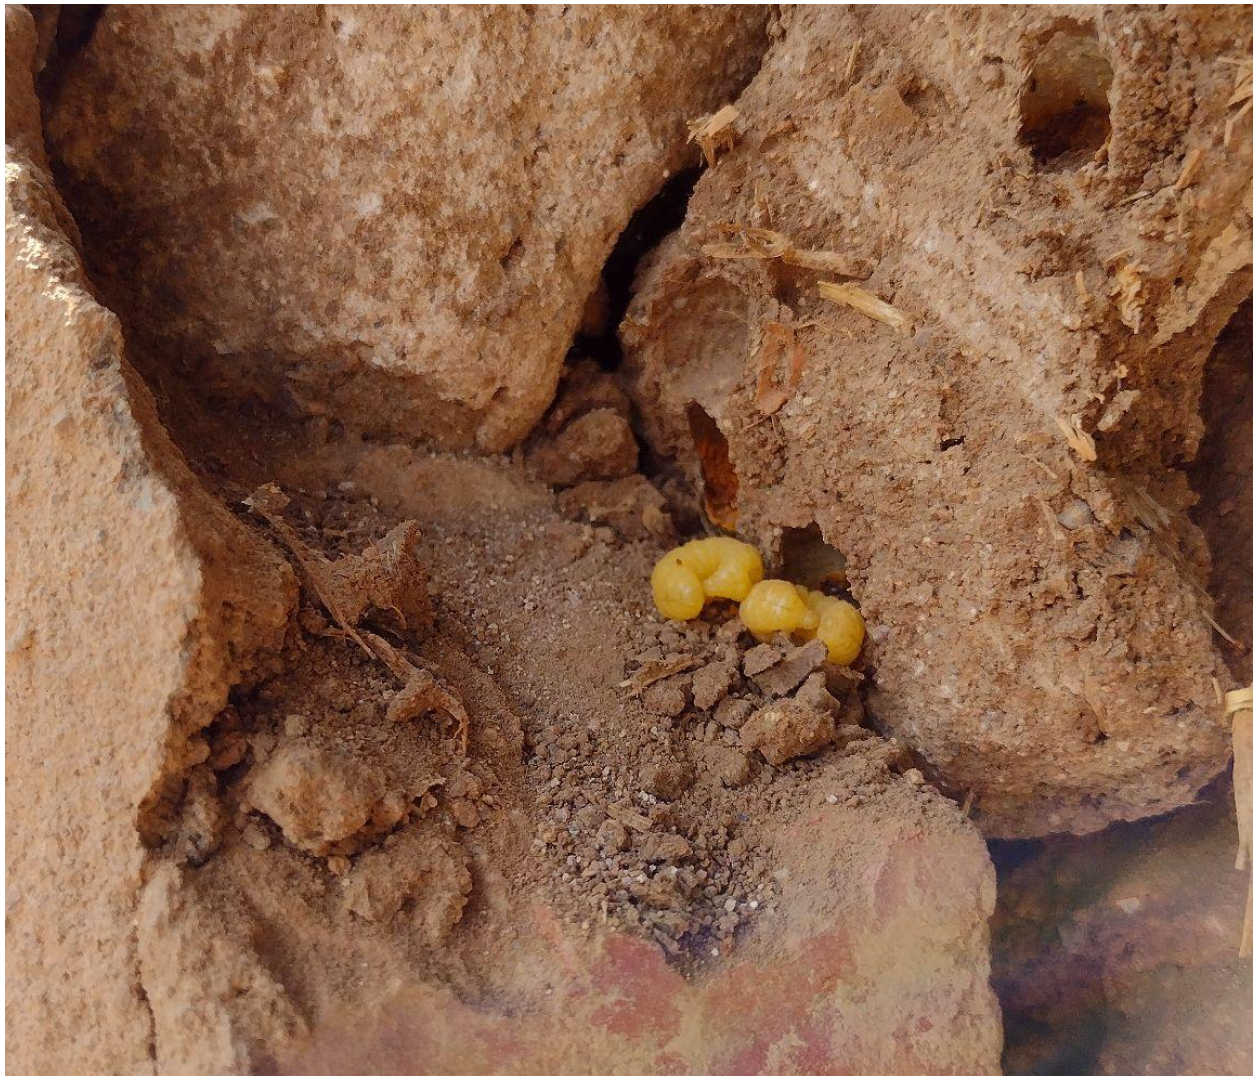
Recent insect burrowing and larvae
