Faith and John Gaw Meem Preservation Trades Internship

My internship with HSFF consisted of 6 weeks primarily on-site at El Zagan building located on Canyon Road in Santa Fe. My first week included an orientation to the city's historic neighborhoods and an overview of how the Foundation's work fits into a bigger context of preservation advocacy and community engagement in the region. My main project was to re-plaster the north wall of the main El Zagan structure that currently house's the Foundation's headquarters and gallery space. The building has two foot thick adobe walls and dates from the mid 1800s, and has seen many layers of maintenance and modifications since then.

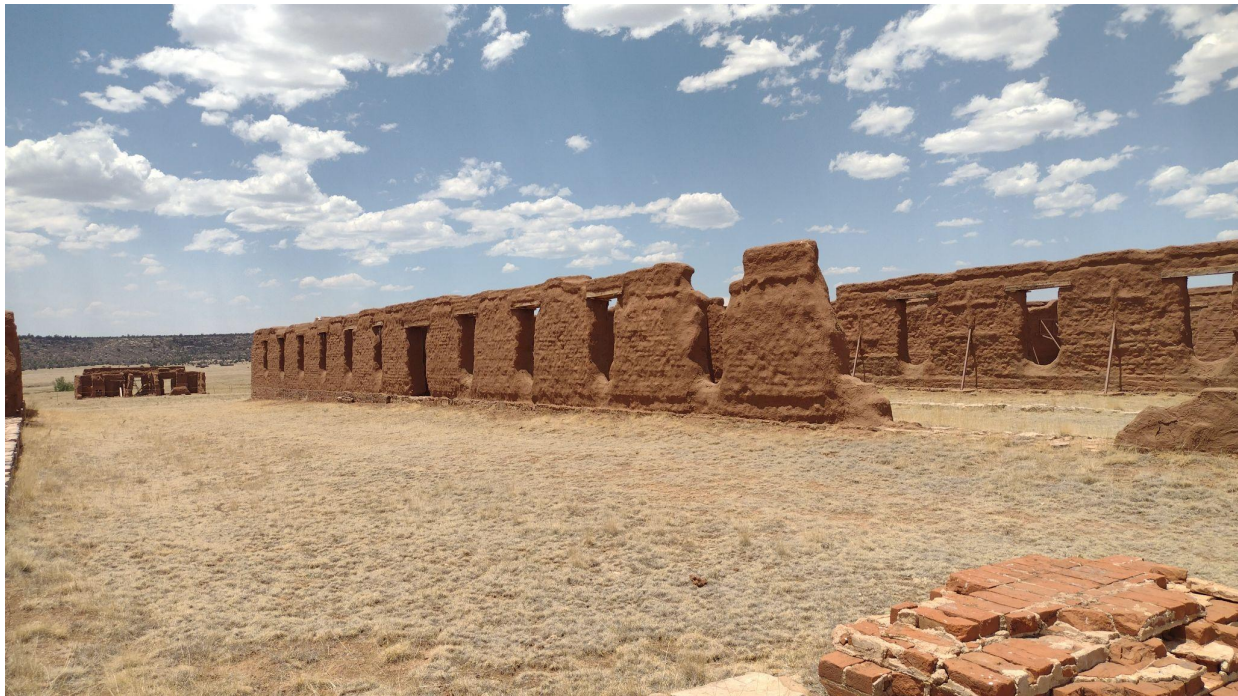
At Fort Union, we saw up-close how the walls are deteriorating, and measures put in place to slow this down. Adobe walls, whether in traditional pueblo buildings or in more recent settler buildings, depend on roof beams to maintain structural integrity. However, re-building roofs on these wall ruins is not currently feasible under NPS preservation standards. Policies may need to change to allow roofs. The tour guides highlighted the ways that walls are surveyed, including the important switch in paradigm from identifying structures by the rooms they once housed, and shifting towards an resource inventory that identifies specific walls, which are each deteriorating at different rates due to varying exposure to weather and elements.

Fort Union National Monument

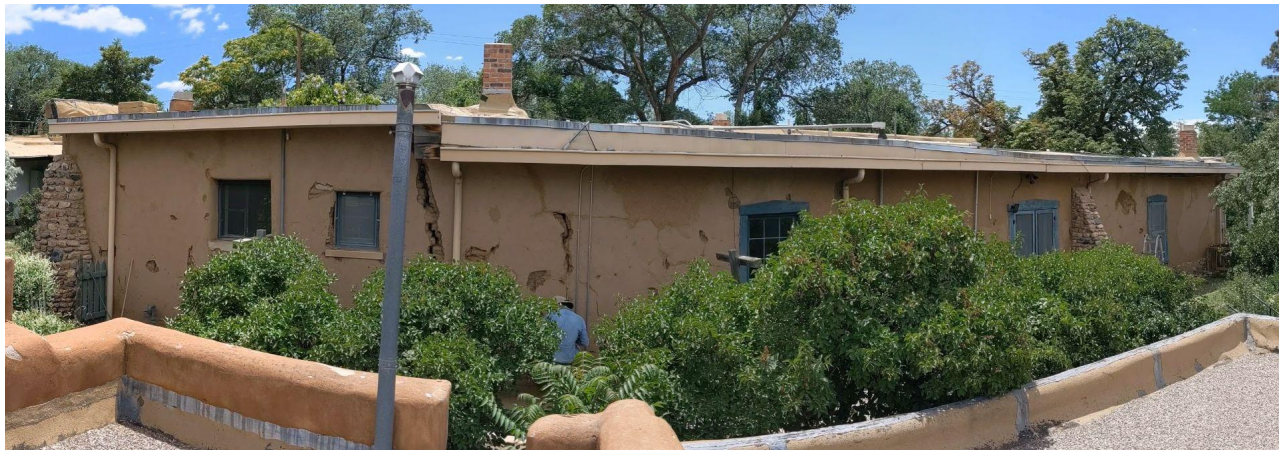
View of entire Northern wall during crack repair, before earthen plastering began

The bricks from the two different walls seem to have separated approximately 2 inches at the widest part of the gap. This is likely caused by the foundation and walls settling at different rates. However, given that there was no significant widening of crack on the most recent layer of plaster, it can be assumed that this settling and separation happened early on in the building's history. Subsequent removal of loose material I did in this area opened up the gap even more, and the adjoining exterior plaster to an even greater extent.

If the building had shifted more recently, and after the most recent layer of plaster, a more obvious superficial crack would be visible. Ideally, when the addition was built, some bricks would have been removed from the old wall, and the new wall would have been 'stitched' into the old wall every few courses of bricks.

Once the gaps and cracks were cleared, the next step was to fill in with earth up to the level of the adobe bricks. I did this with two types of mixes depending on the ease with which they could be applied. The first type was a 'dry mix' of the same proportions of clay, sand and straw used for plaster, but with little water. This would be tamped into gaps. However, the loose nature of this 'dry mix' was difficult to apply to hard-to-reach areas, and often resulted in most of the material falling out of the gaps while I attempted to pack it in. I found that a wetter cob-like mixture with higher proportions of straw was much easier to apply, in particular in the large gap by the addition.

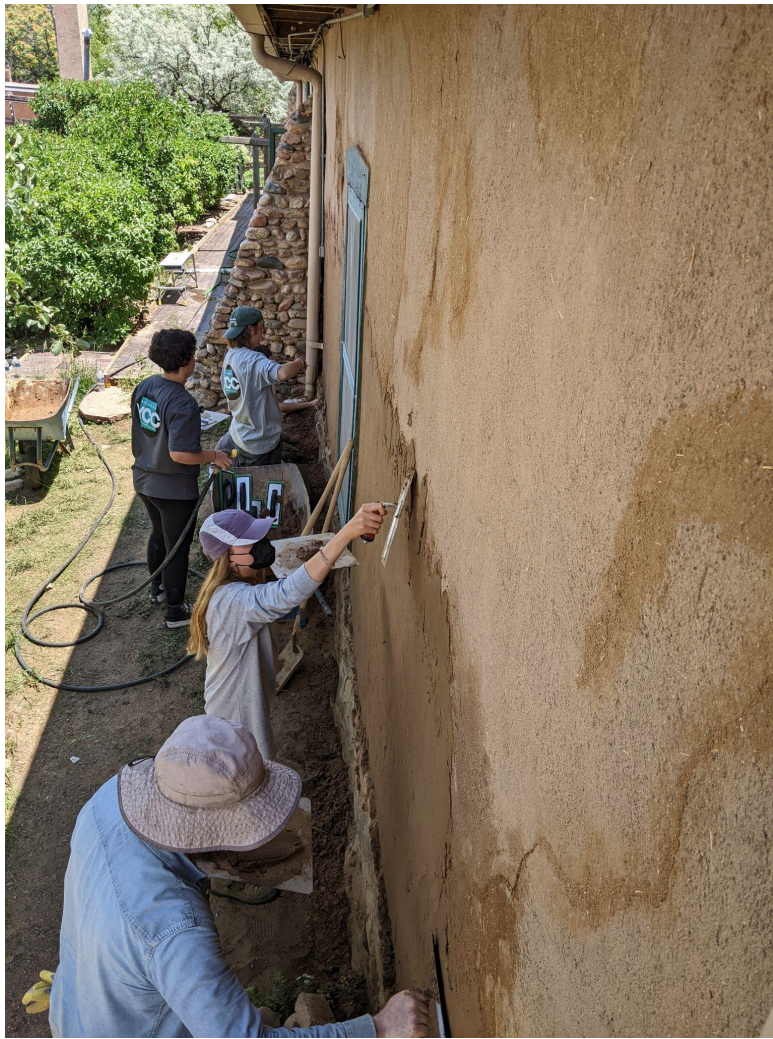
Members of the Youth Conservation Corps applying the first layer of new plaster

Once this was done, it was time to add a final layer of plaster. I began this process of adding a final layer of plaster on the western end of the building even while there was still repair work to do on the remainder of the wall. We had a group of Youth Conservation Corps members who helped add a layer of plaster along the lower half of the wall near the gallery window.

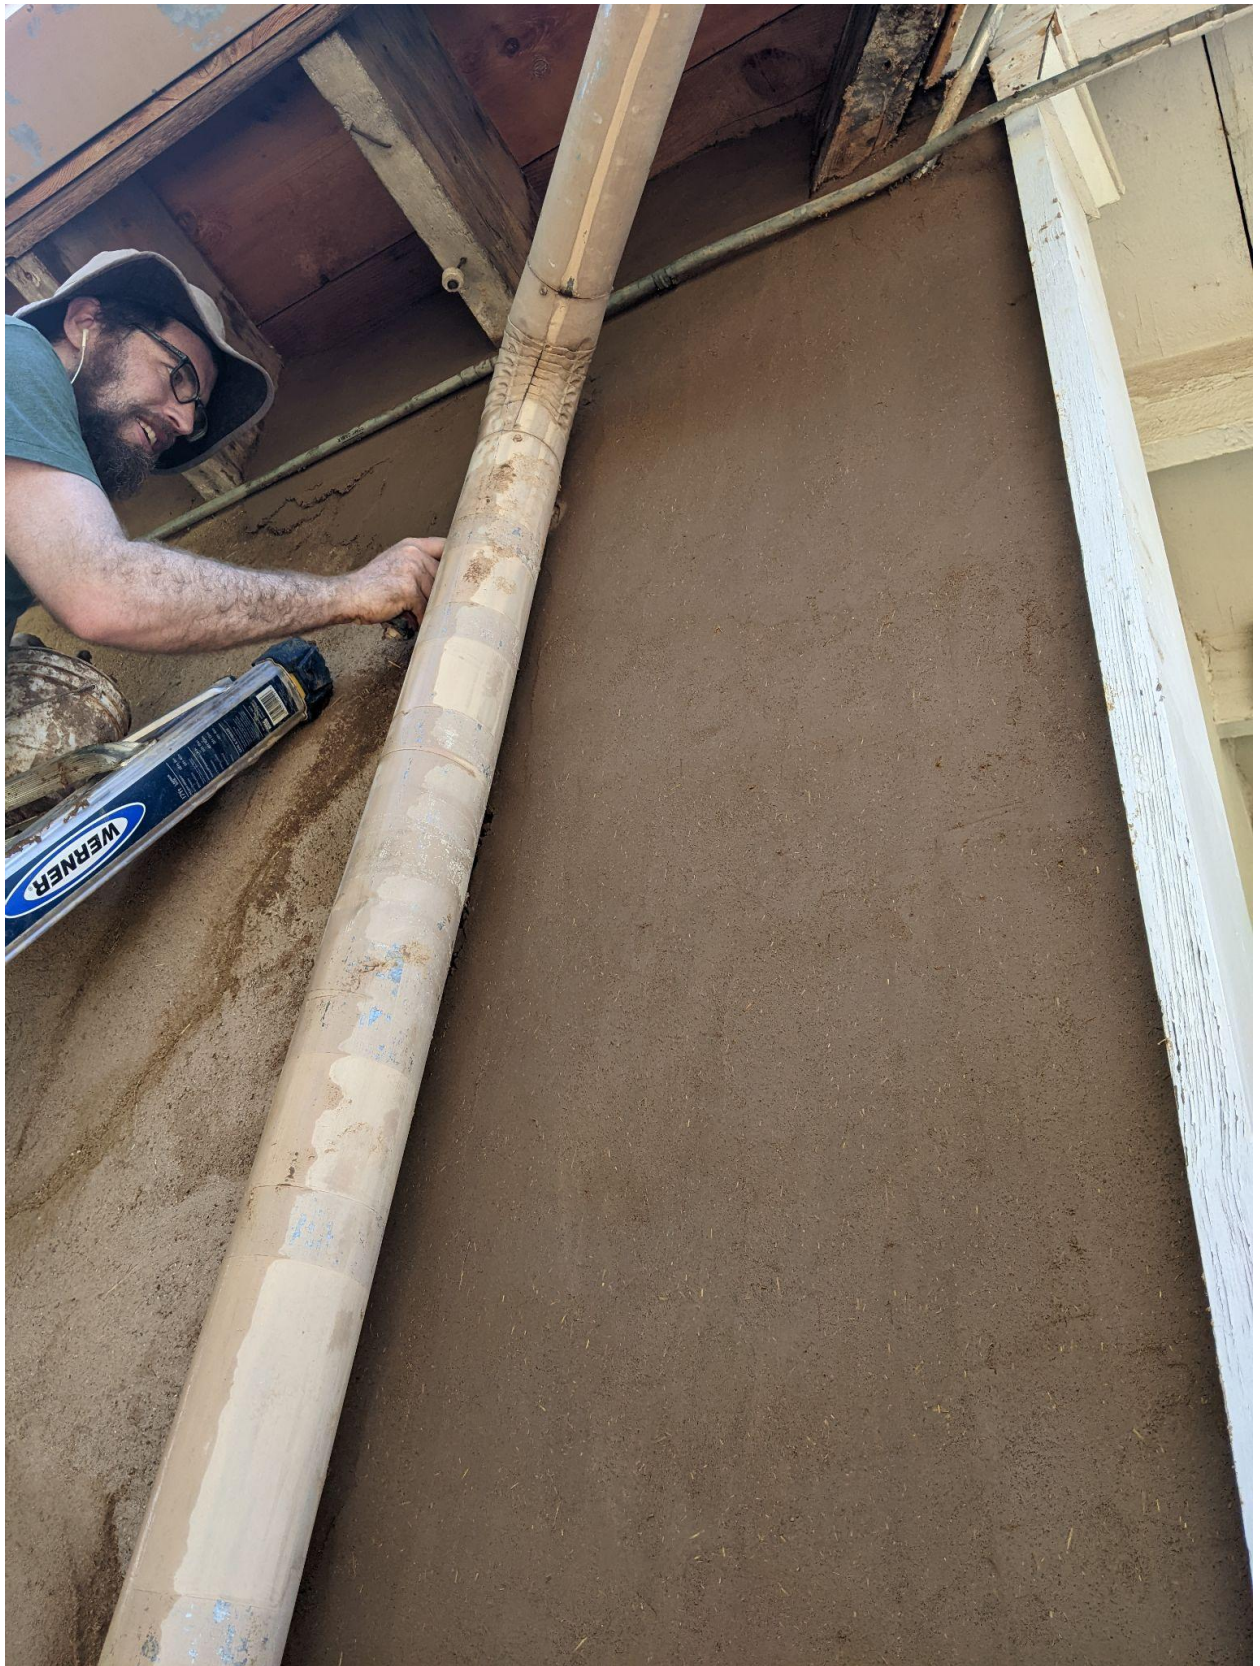
When the plaster is freshly applied, the straw contrasts with the damp clay

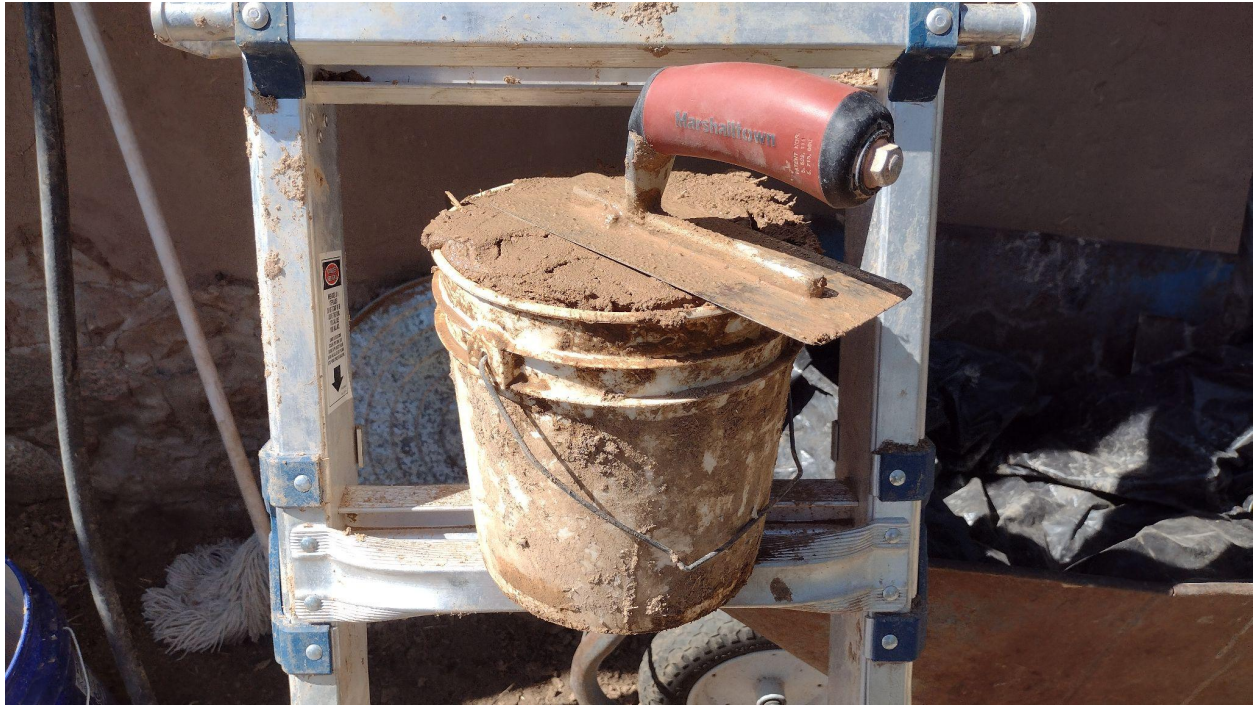
A gallon of prepared earthen plaster ready for application

The mix I used for the plaster was 8:5:1 clay:sand:straw by volume, and each batch tended to be that ratio measured in gallons (ie 8 gallons, 5 gallons, 1 gallon respectively). The clay was from a stockpile stored near the HSFF parking area, and the sand was Quickcrete Play Sand from a hardware store. The straw was chopped with a leaf mulcher. The measurement for the straw was the least consistent across batches, as the straw was processed into varying degrees of fineness by the mulcher.

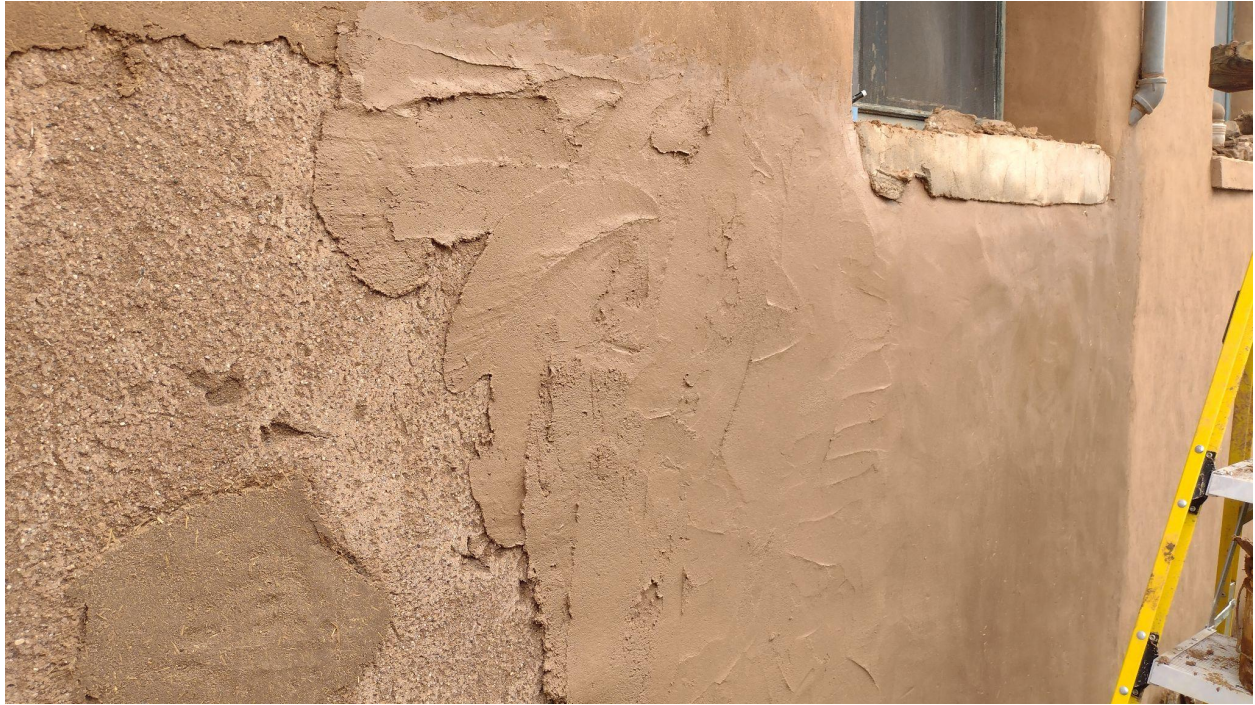
Freshly applied plaster using coarse trowel strokes, which are then smoothed over in another pass with the trowel while it dries

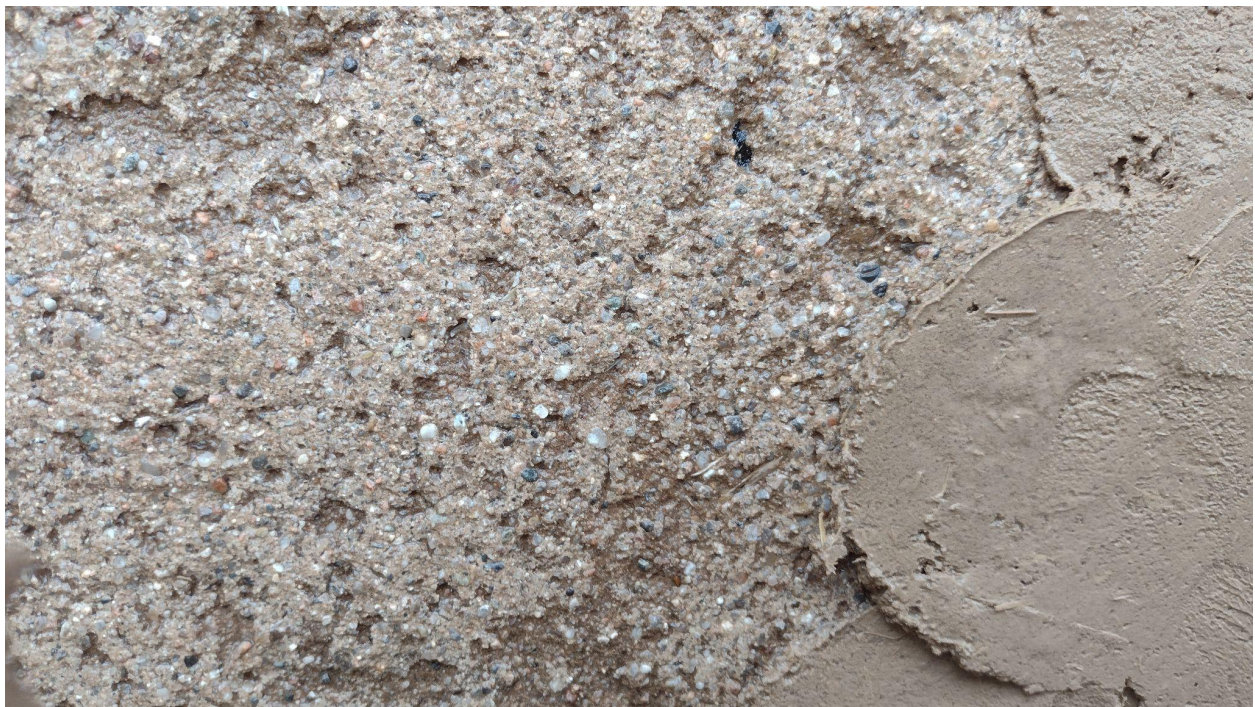
Freshly applied plaster (right) contrasts with the 'pink' layer underneath

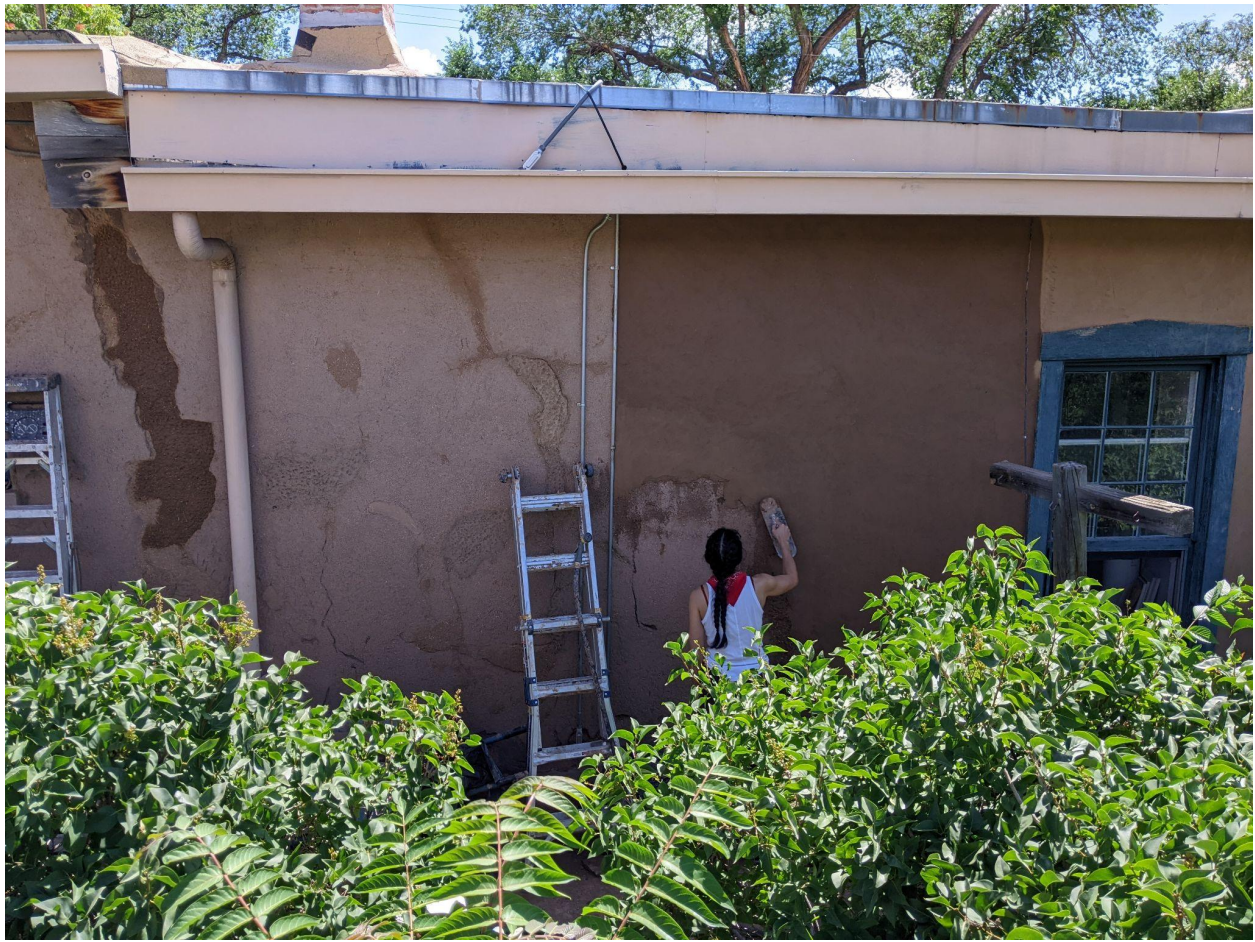
Much appreciated assistance to get the final layer of plaster applied

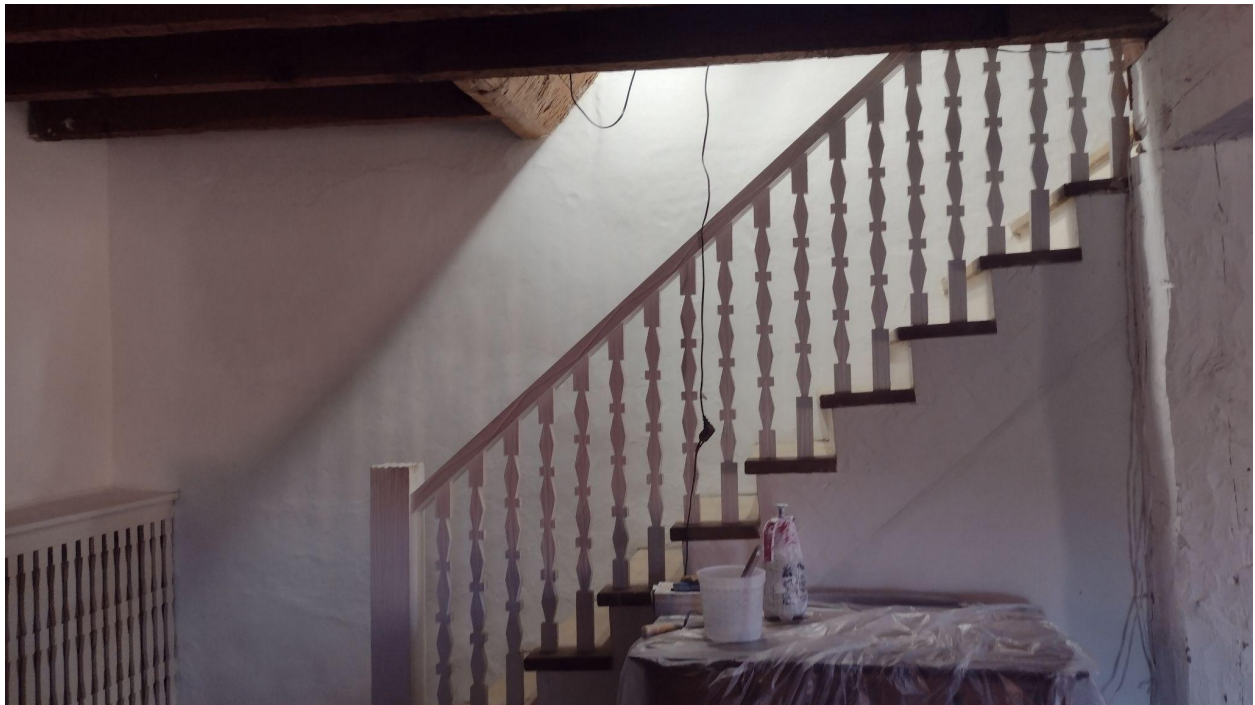
Limewashed wall along stairwell at Randall Davey house

Aside from the replastering project on the wall at El Zaguan, I had a chance to work on painting a wall at the Randall Davey House, further up Canyon Road. Previous work had already been done to repair deteriorating material along the staircase to the second floor of the house. The wall needed a couple more coats of limewash, which is a simple mixture of lime and water.
